# THE ENGINEERING GEOLOGY OF FRANKTON ARM.

A thesis  
submitted in partial fulfilment  
of the requirements for the degree  
of  
Master of Science in Engineering Geology  
in the  
University of Canterbury  
by  
**DEBORAH LOUISE STOSSEL**

University of Canterbury,  
June, 1999.

Seven bedrock landslides situated within quartzofeldspathic schist exist up slope of the residential area along the Frankton Arm of Lake Wakatipu, South Island, New Zealand. Engineering geological and geotechnical failure models for these landslides have been established using engineering geological mapping at scales of 1:5000 and 1:10000, geotechnical testing, and the development of limit-equilibrium sensitivity models.

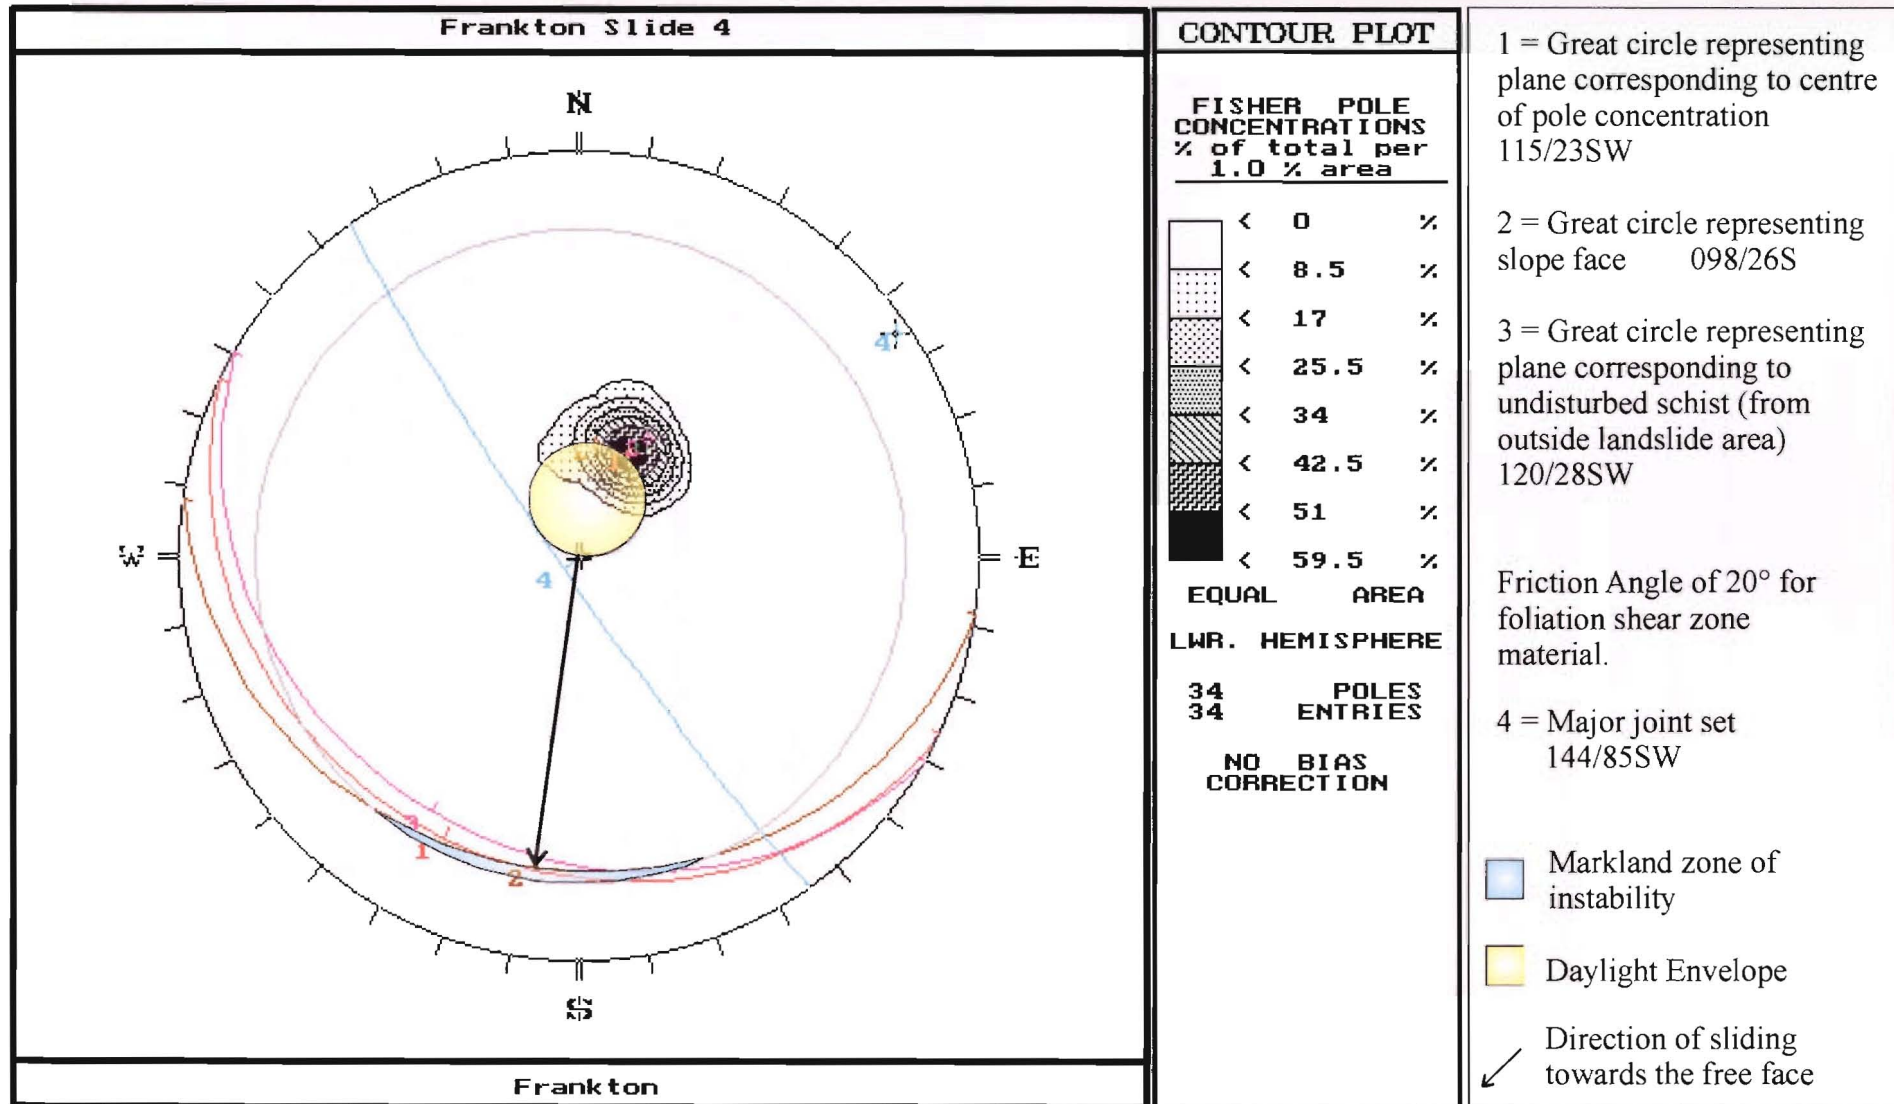
Figure 5.21: Stereonet showing major structural controls of the No. 4 Failure, using a friction angle of 20°, a value assumed for foliation shear zone material. There is a Markland's zone of instability formed.

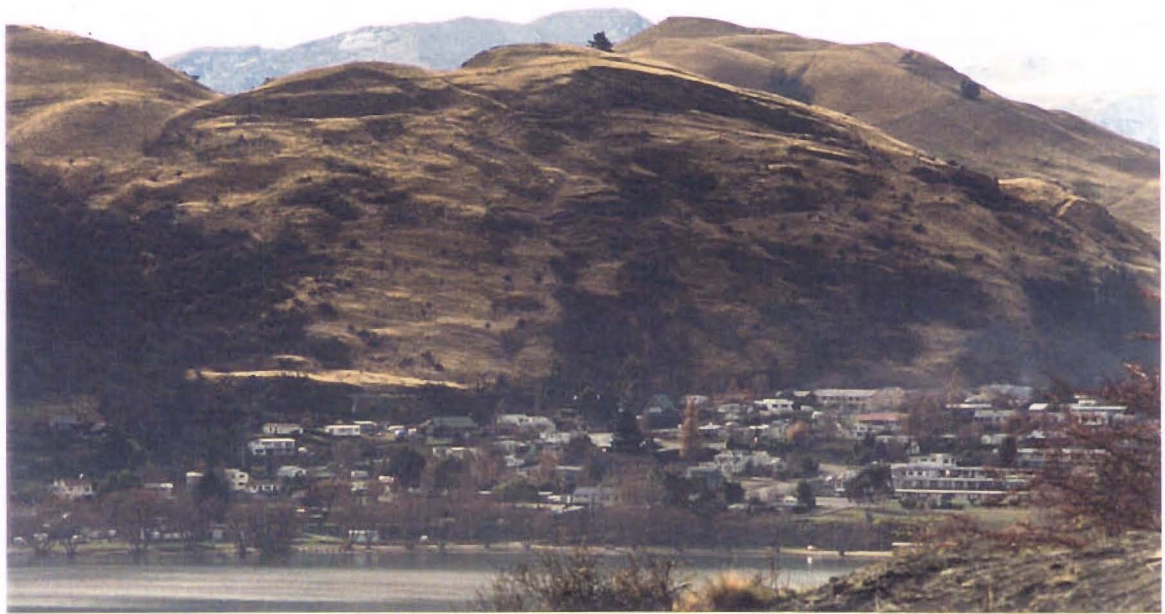
Figure 5.22: Slide No.'s 5 and 6 showing hummocky topography. Note the prominent sunlit beach terrace at the base of Slide No. 5.

Bedrock consists of quartzofeldspathic schist, with an average foliation attitude of 110/29S. This slide is the most degraded of all the slides along Frankton Arm, but still shows marked hummocky topography (figure 5.22). The head scarp is poorly developed and not broken through the soil cover, or has been re-vegetated with a prominent retrogressive scarp situated above the main head scarp (figure 5.3 and figure 5.4). A 4WD track has been cut across the slide mass and scarps with apparently no reactivation or movement. There is no sign of tilting of the power poles placed on the slide mass. Exposures of weak pelitic schist occur in the 4WD track cuttings.

The toe area has formed along the +48m beach terrace, which is easily distinguished from aerial photographs. An irrigation canal, constructed by the 1950's, runs along the top of this beach terrace (see figure 5.22). The lower section of the western lateral margin consists of a deeply incised stream (figure 5.1 and figure 1.2 – map pocket).

Slide No. 6 has a volume of  $7.0 \times 10^5 \text{m}^3$  and an area of  $7 \text{km}^2$ . The landslide is situated on the northeastern edge of Frankton Arm (figure 5.1; figure 1.2 – map pocket). The head scarp trends northwest-southeast, similar to the other slides, and is prominently joint-controlled. Again, the +48m beach terrace cuts across the toe of the slide along with the irrigation canal. The scarps of this slide are not as degraded as they are on Slide 5, and this may be attributed to the change in strike of the slope face which causes the strike of the foliation to be a lot similar in orientation to the strike of the slope face, a factor contributing to increased levels of instability. However, the head scarp has still not broken through the soil cover. The western lateral margin coincides in places with the eastern margin of Slide No. 5 and the eastern margin acts as a lateral release structure on which movement can occur (figure 5.22).

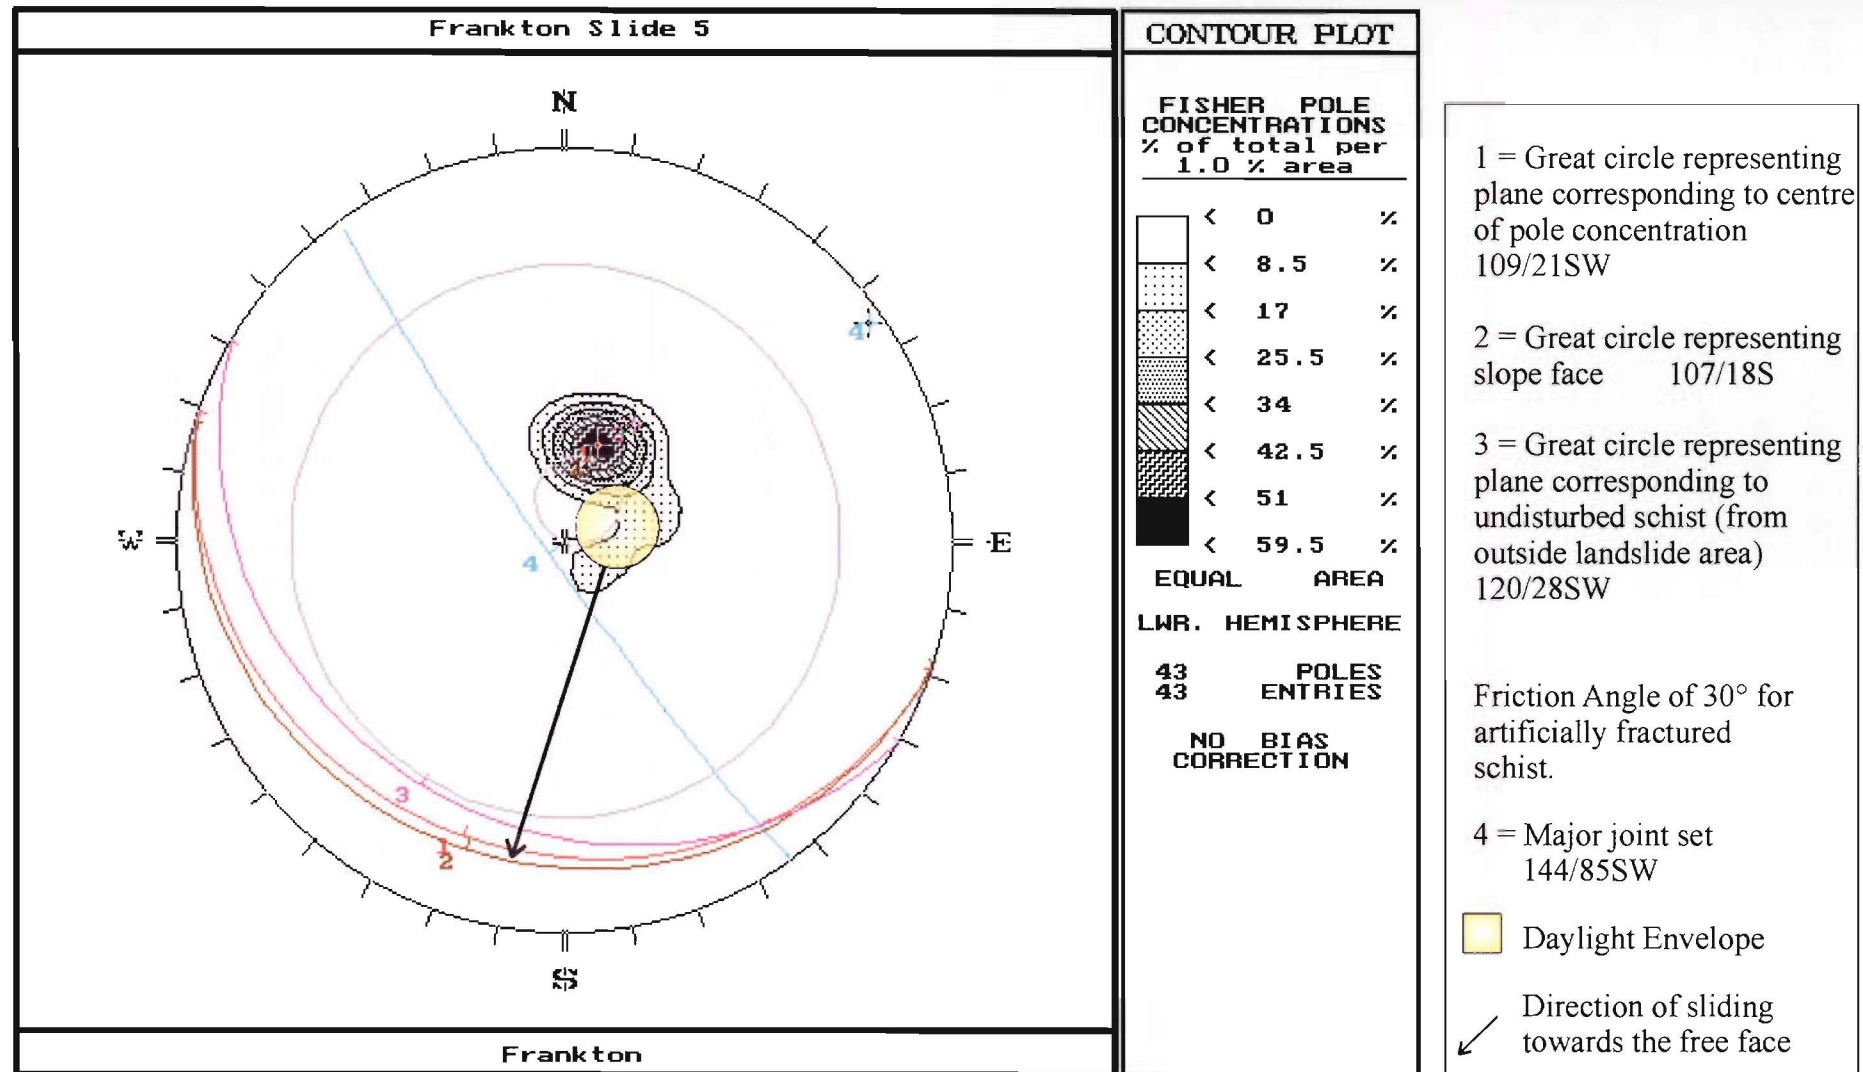
Figure 5.23: Stereonet showing major structural controls of the No. 5 Failure, using a friction angle of 30°, a value obtained from laboratory testing of artificially fractured schist collected from outside the slide area. There is no Markland's zone of instability formed

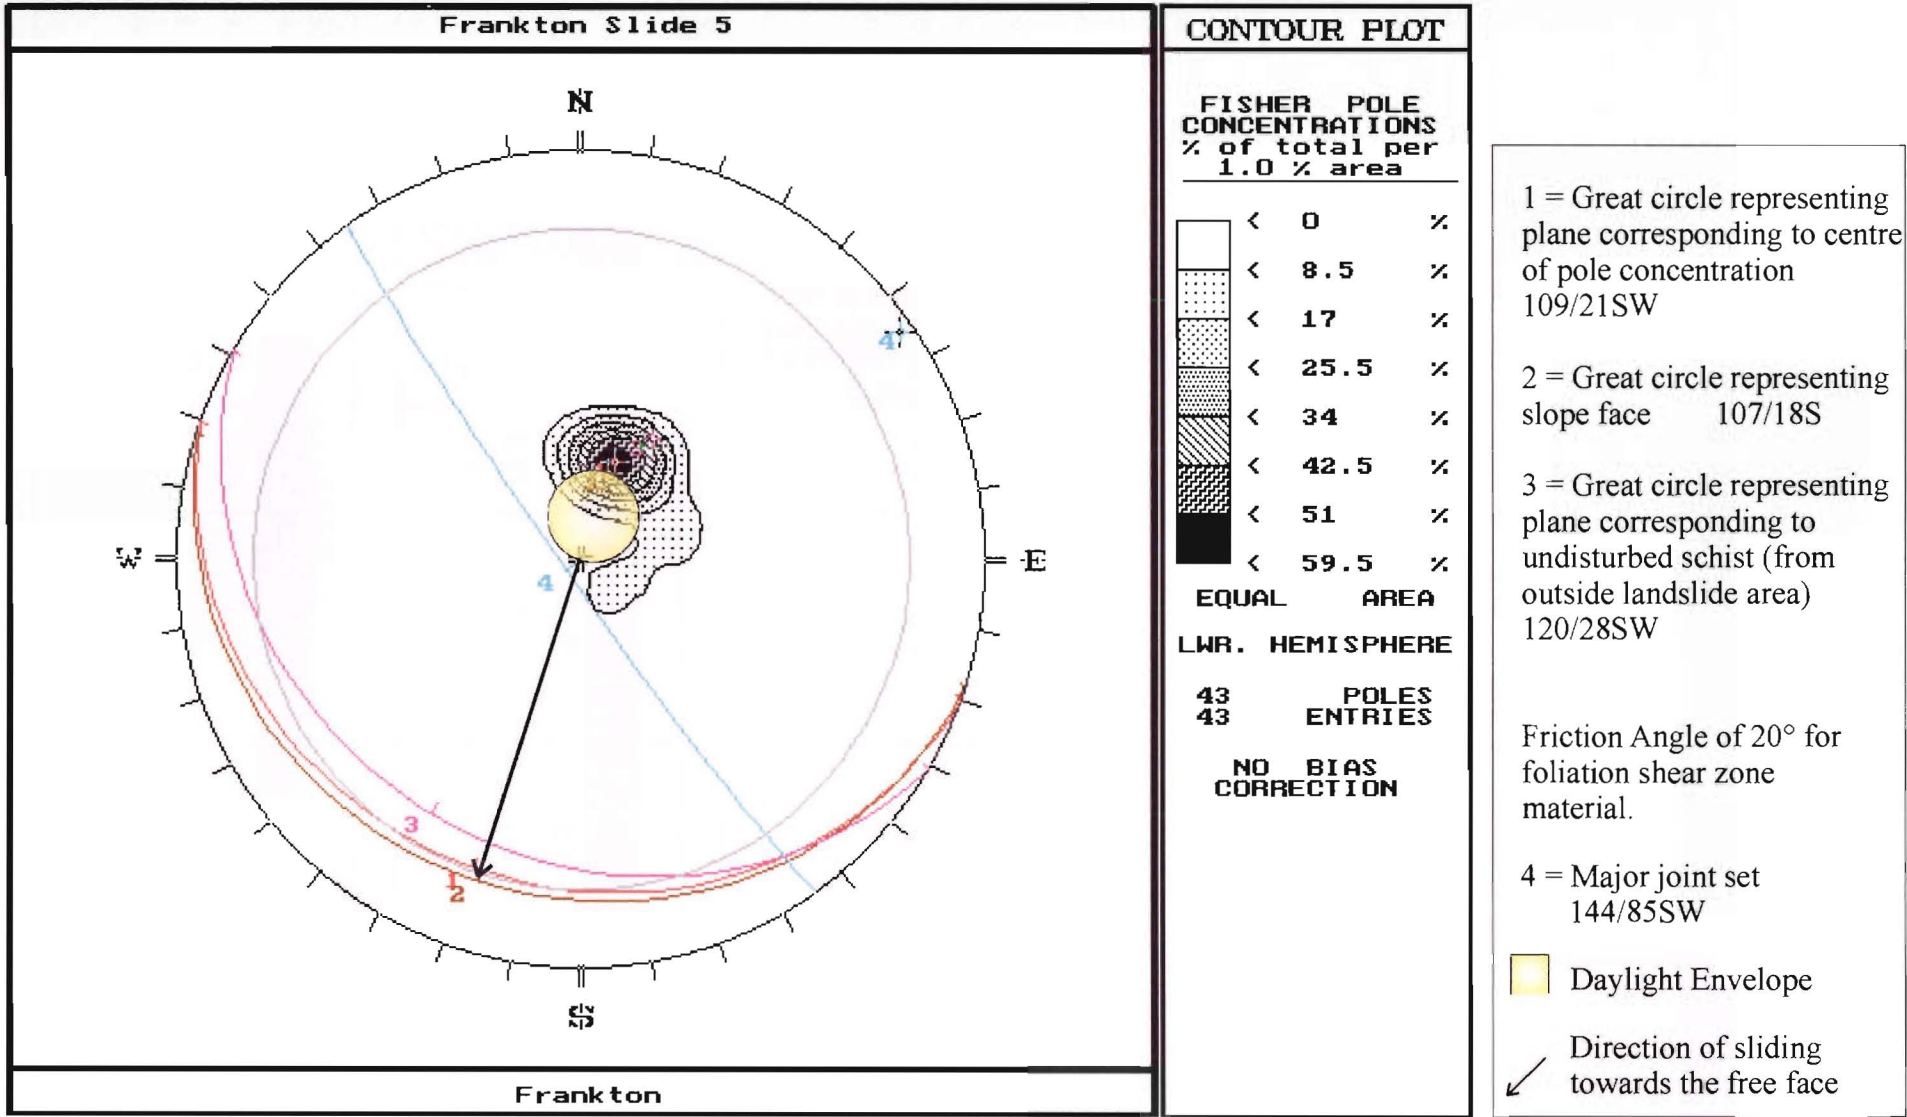
Figure 5.24: Stereonet showing major structural controls of the No. 5 Failure, using a friction angle of 20°, a value assumed for foliation shear zone material. There is no Markland's zone of instability formed

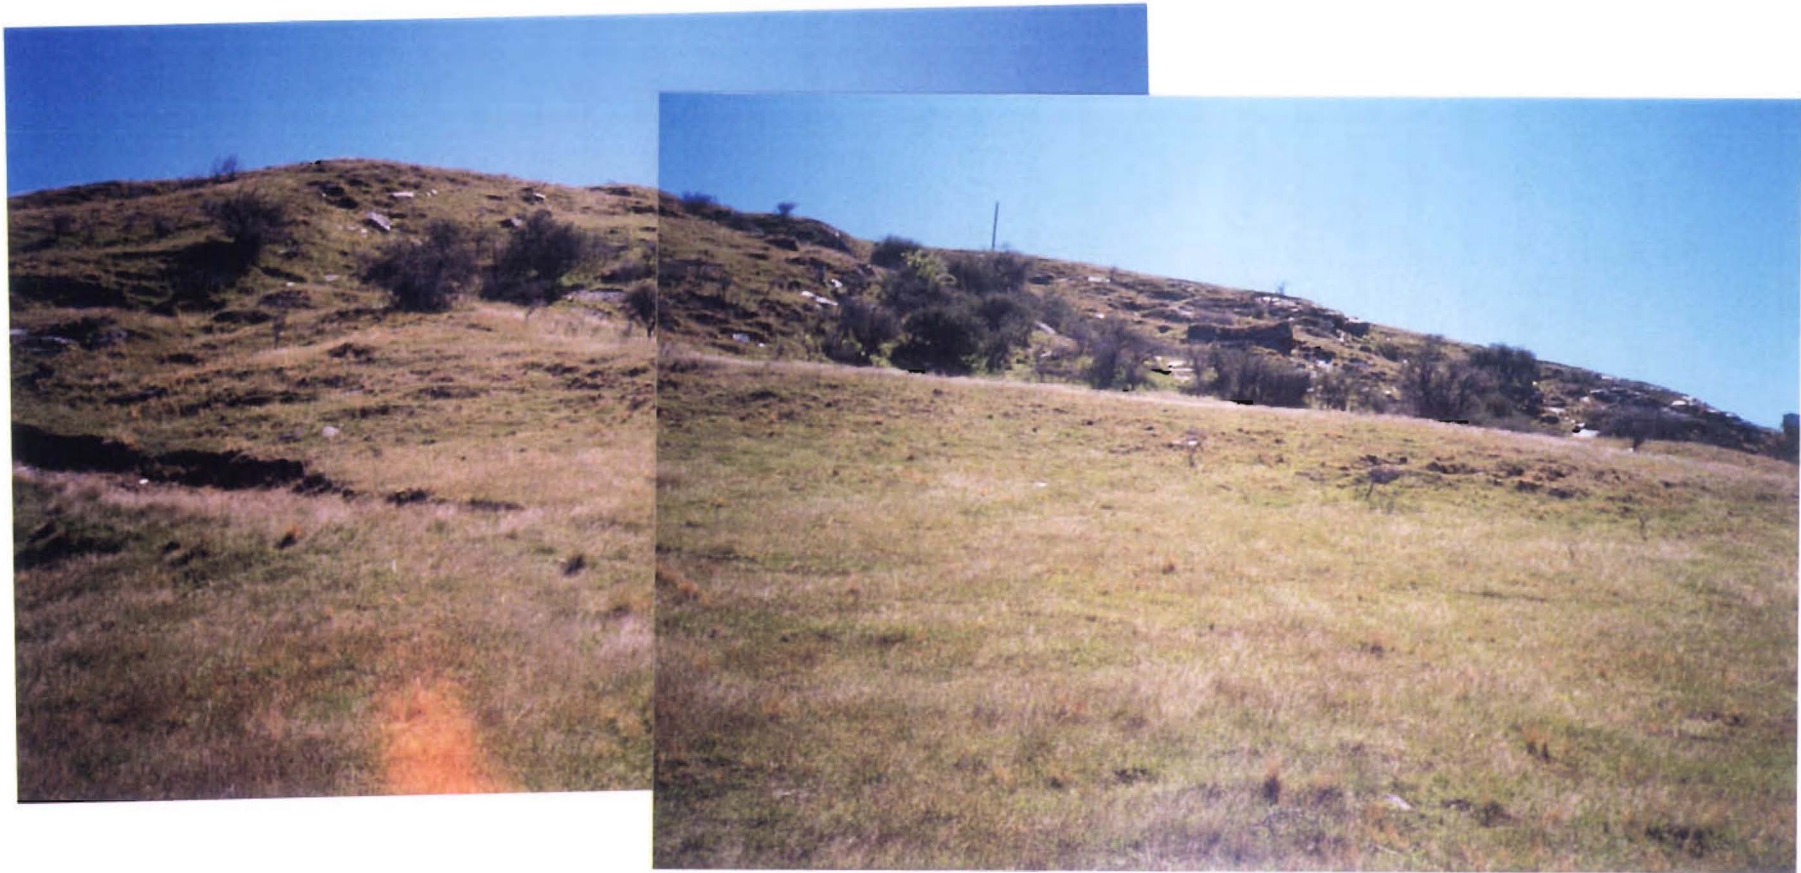
Figure 5.25: The head scarp of Slide number 6 (at the sky line) showing degradation and the establishment of vegetation.

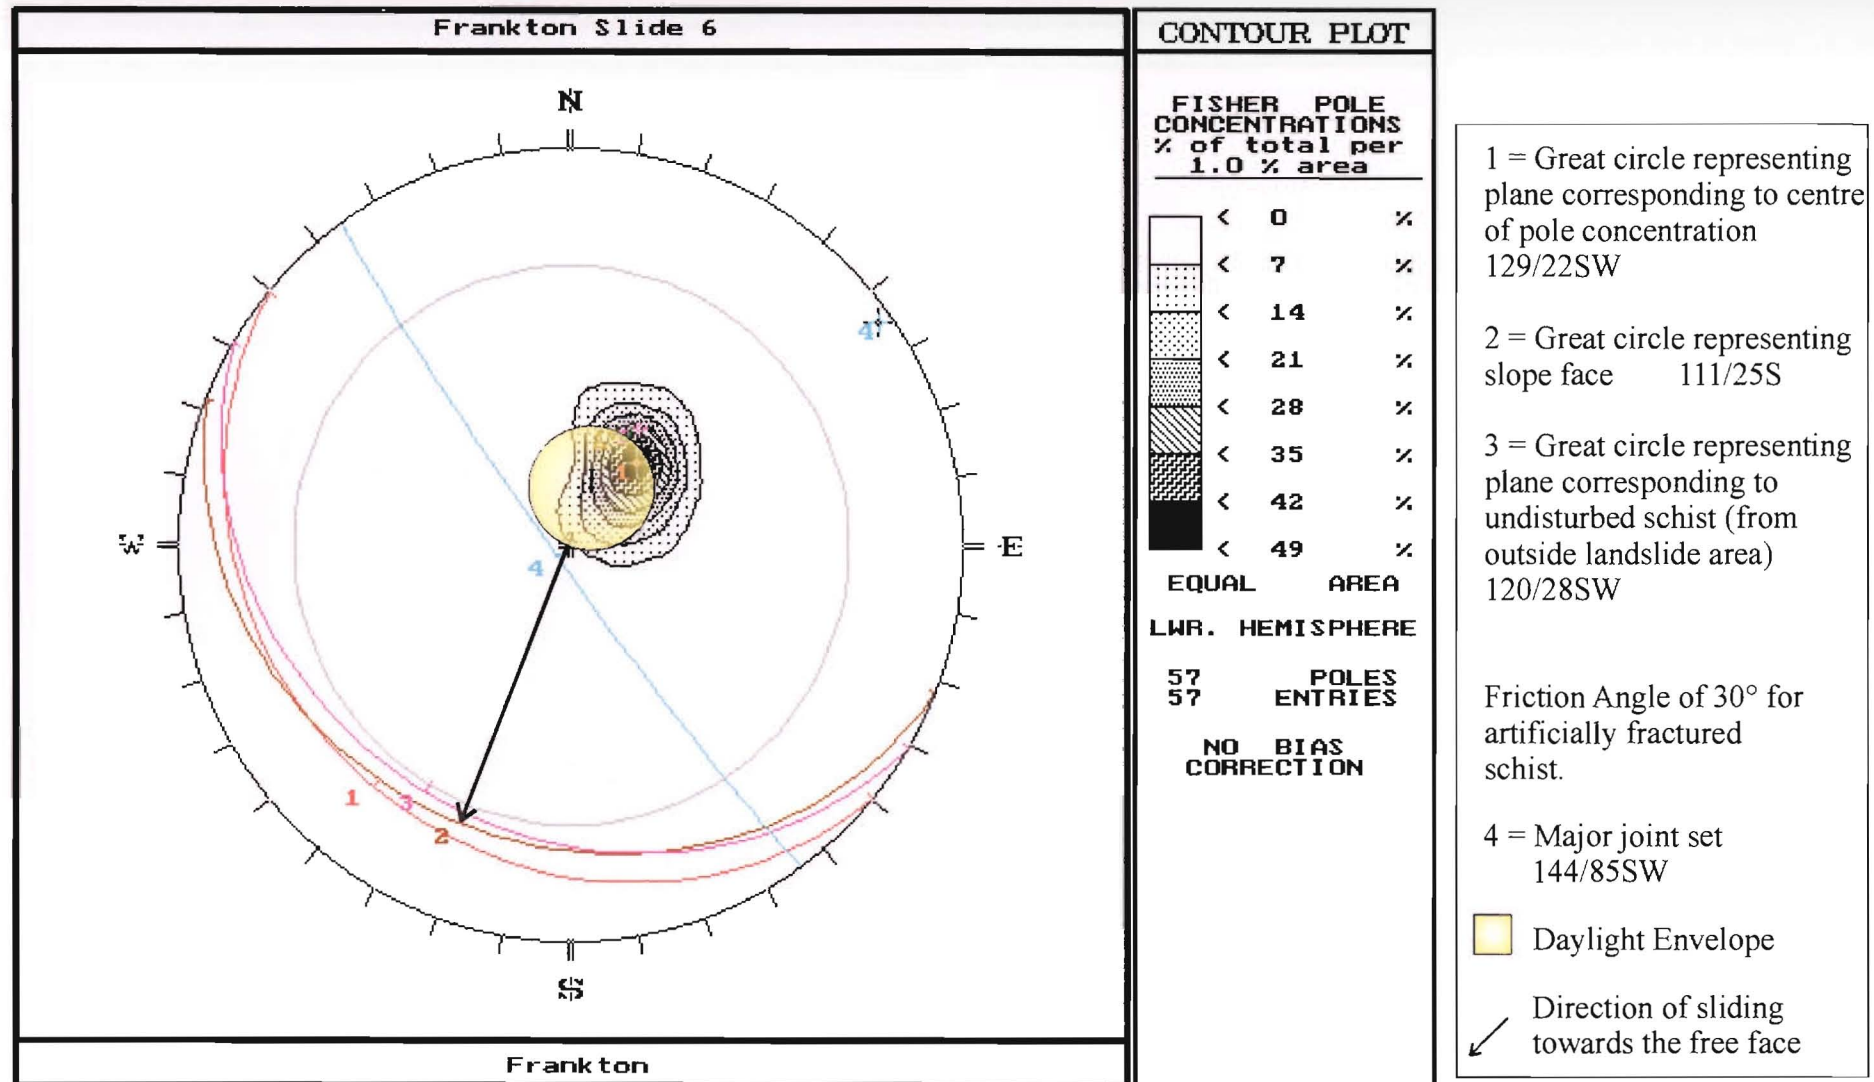
Figure 5.26: Stereonet showing major structural controls of the No. 6 Failure, using a friction angle of  $30^\circ$ , a value obtained from laboratory testing of artificially fractured schist collected from outside the slide area. There is no Markland's zone of instability formed.

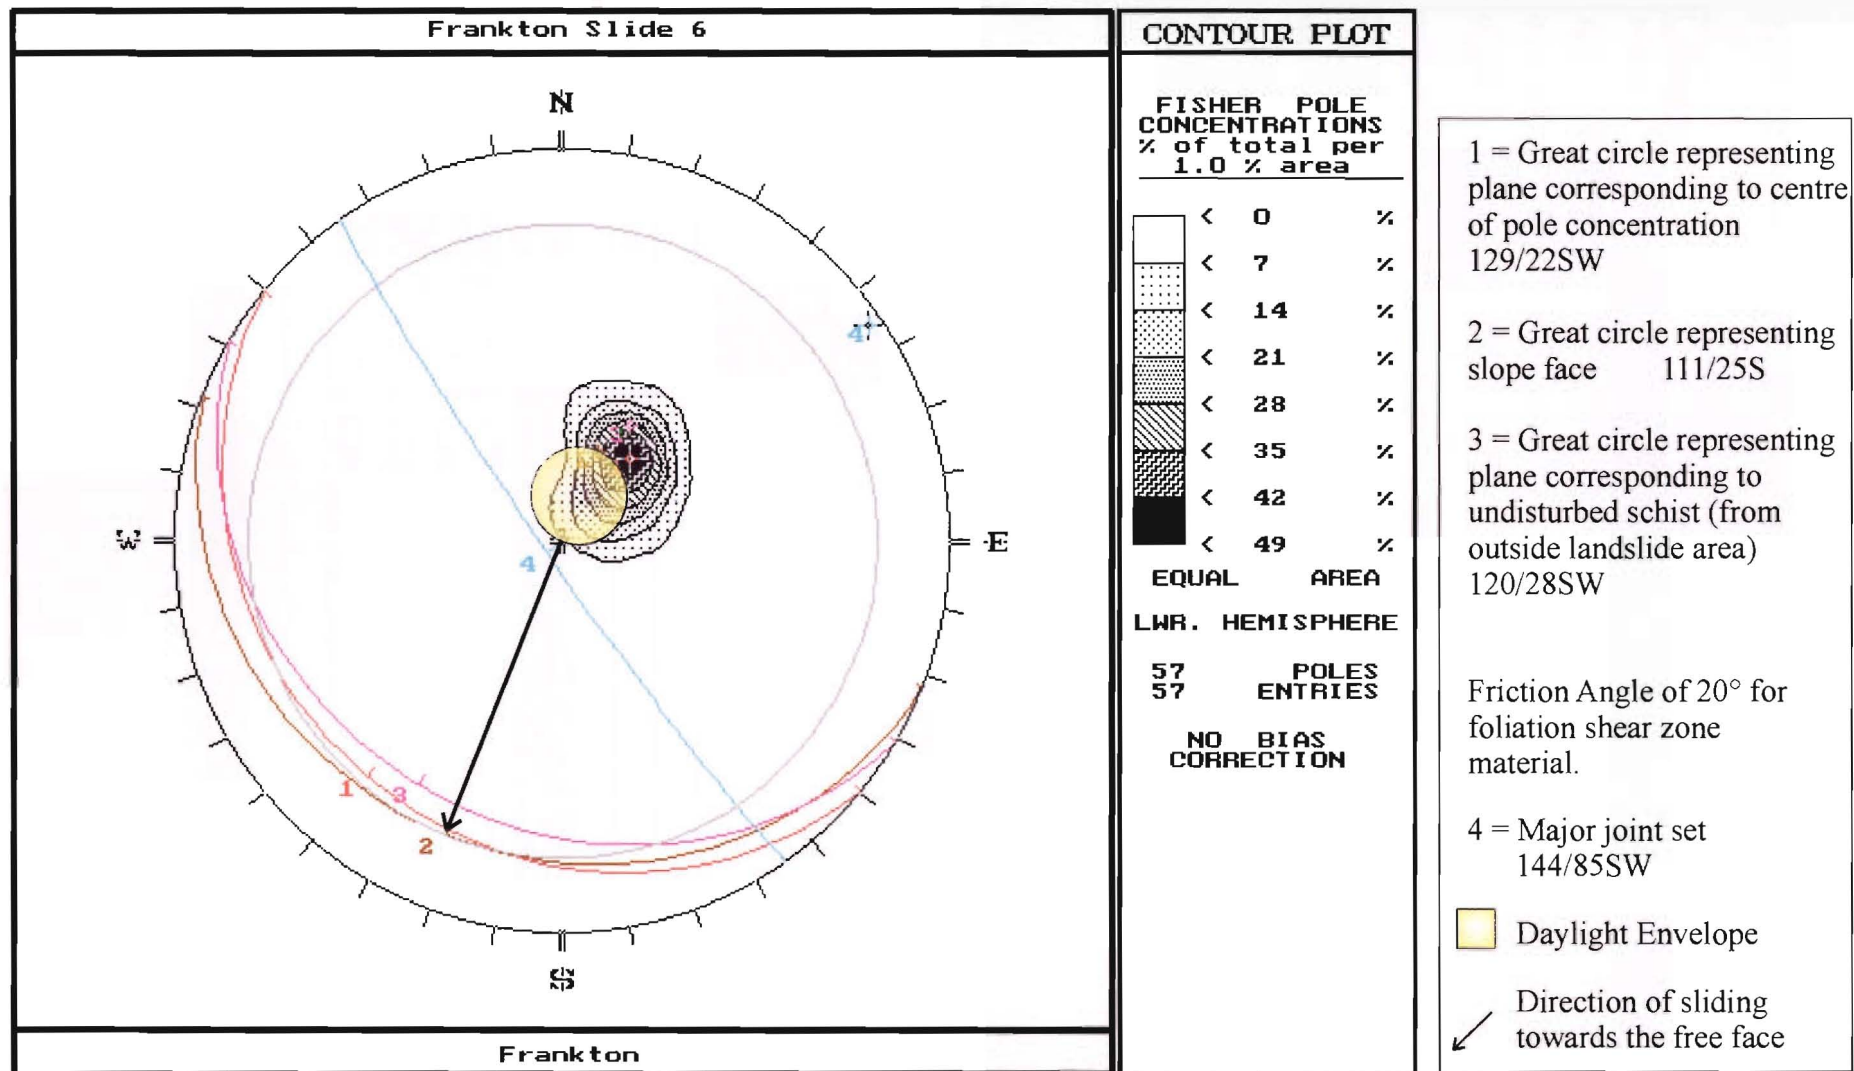
Figure 5.27: Stereonet showing major structural controls of the No. 6 Failure, using a friction angle of  $20^\circ$ , a value assumed for foliation shear zone material. There is no Markland's zone of instability formed.

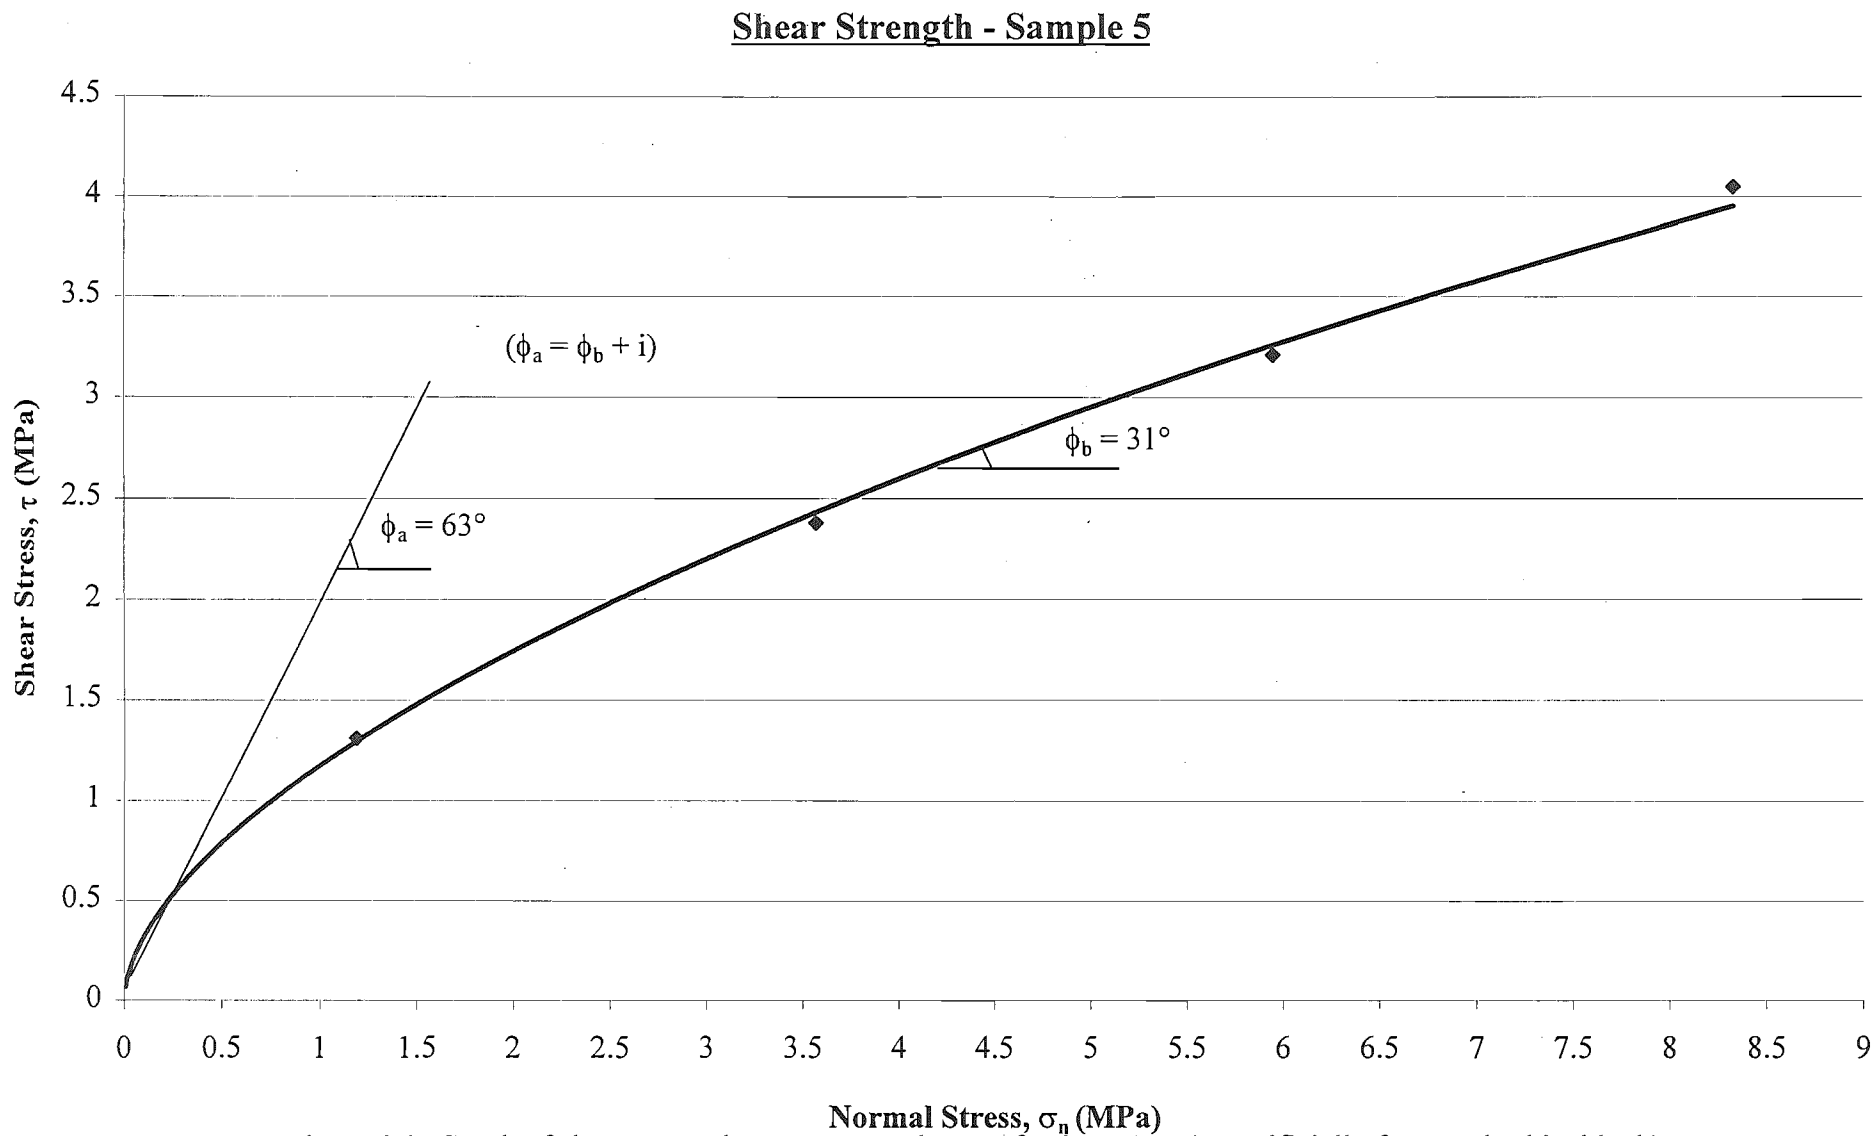
Figure 3.2: Graph of shear strength versus normal stress for Sample 5 (an artificially fractured schist block)
